FULL RESERVE STUDY

Pheasant Run Condominium Homeowners Association, Inc.

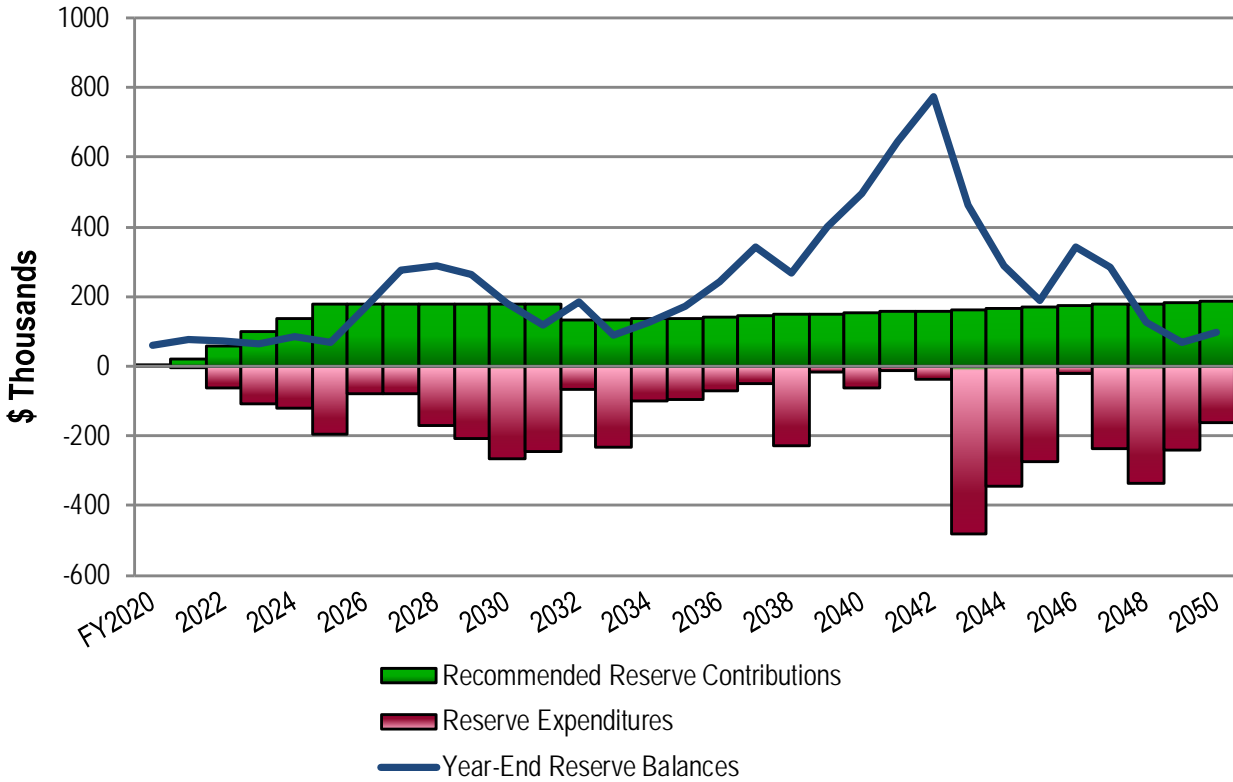
Year	Reserve Contributions (\$)	Reserve Balances (\$)	Year	Reserve Contributions (\$)	Reserve Balances (\$)	Year	Reserve Contributions (\$)	Reserve Balances (\$)
2021	20,546 (Budgeted)	77,106	2031	180,500	117,338	2041	156,600	644,047
2022	59,500	73,418	2032	131,000	185,027	2042	159,700	772,984
2023	98,500	65,925	2033	133,600	88,649	2043	162,900	461,936
2024	137,500	83,916	2034	136,300	124,855	2044	166,200	288,361
2025	176,500	68,239	2035	139,000	170,864	2045	169,500	187,950
2026	180,500	170,036	2036	141,800	244,529	2046	172,900	341,374
2027	180,500	275,768	2037	144,600	342,993	2047	176,400	282,260
2028	180,500	286,784	2038	147,500	266,461	2048	179,900	126,624
2029	180,500	263,208	2039	150,500	402,110	2049	183,500	68,605
2030	180,500	179,919	2040	153,500	496,162	2050	187,200	96,193

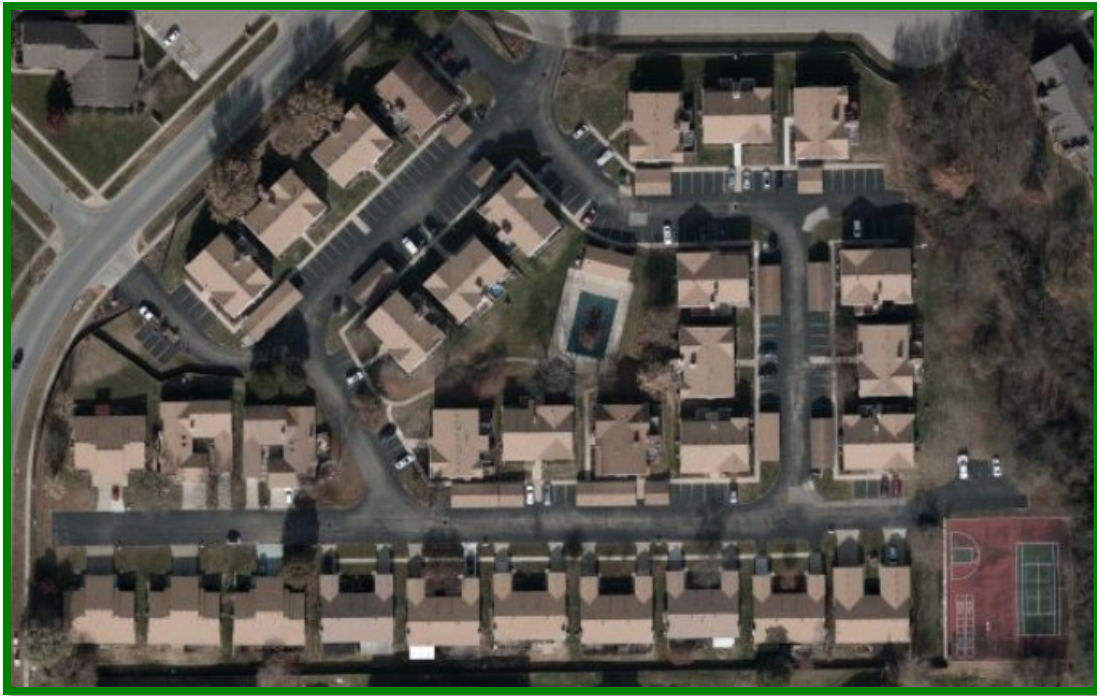
Our investigation includes Reserve Components or property elements as set forth in your Declaration. The Expenditure tables in Section 3 list the elements contained in this study. Our analysis begins by segregating the property elements into several areas of responsibility for repair and replacement.

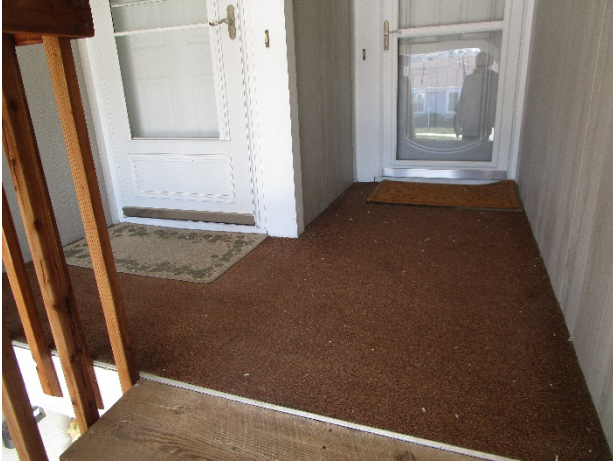
Staircase landing carpet floor covering

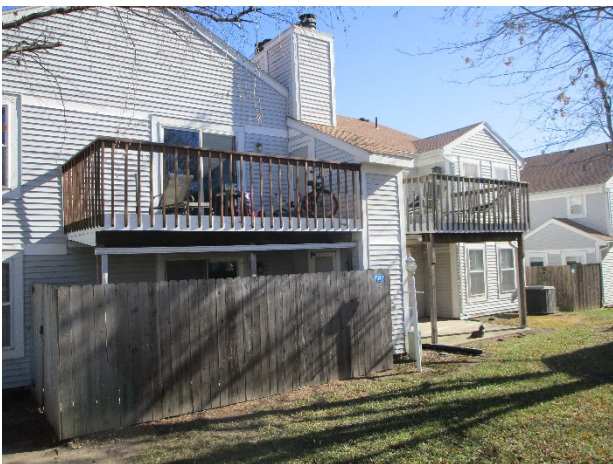
Balcony, patio and privacy fence

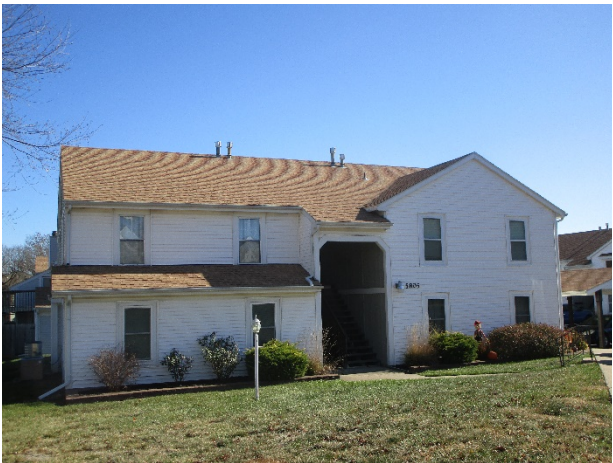
Apartment style fourplex front elevation

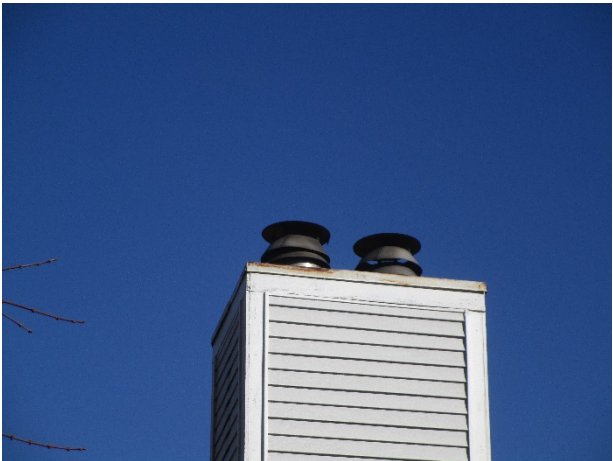
Metal chimney cap; Note rust

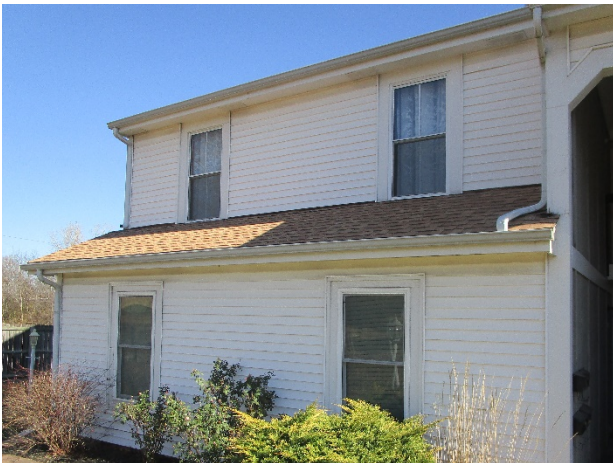
Gutter and downspout assembly

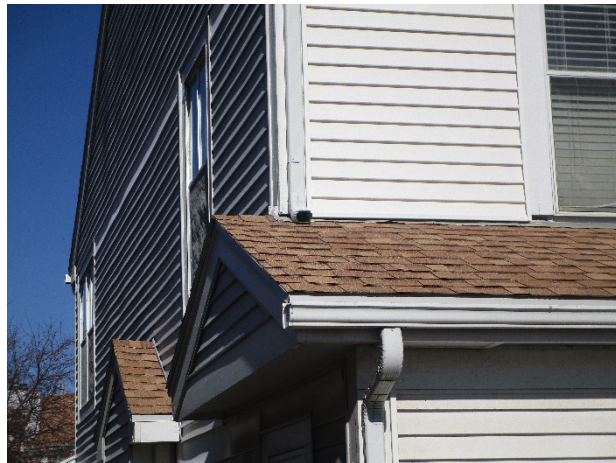
Downspout drainage directly onto the roof

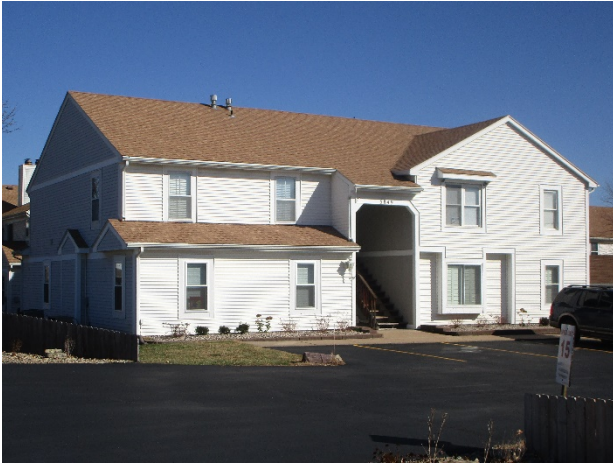
Asphalt shingle roof overview

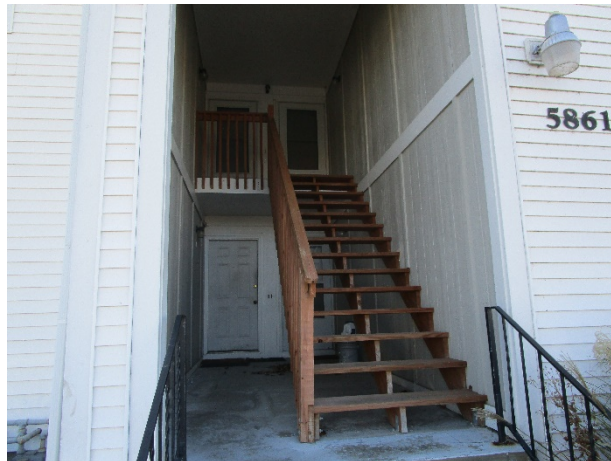
Condition: Good overall

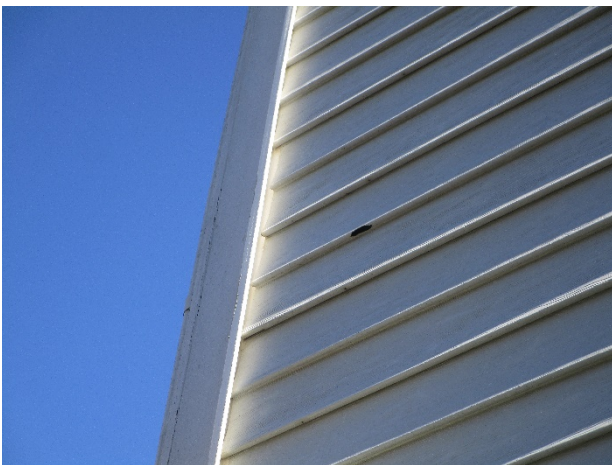
Siding damage at Building 5803

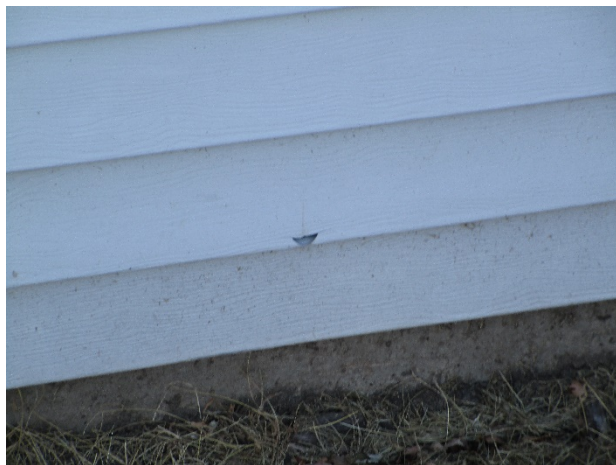
Siding damage at Building 5849

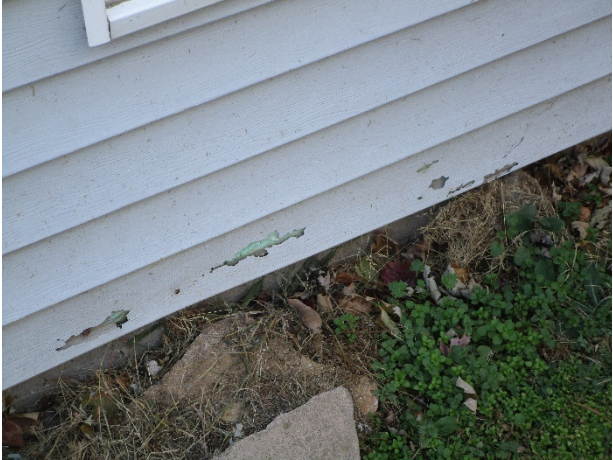
Siding damage at Building 5859

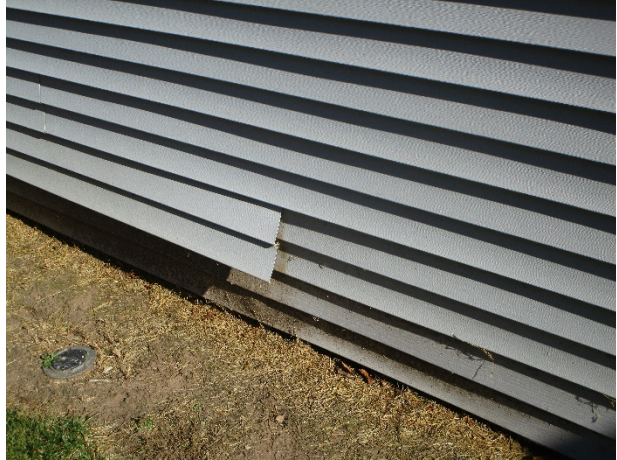
Loose siding at 5835

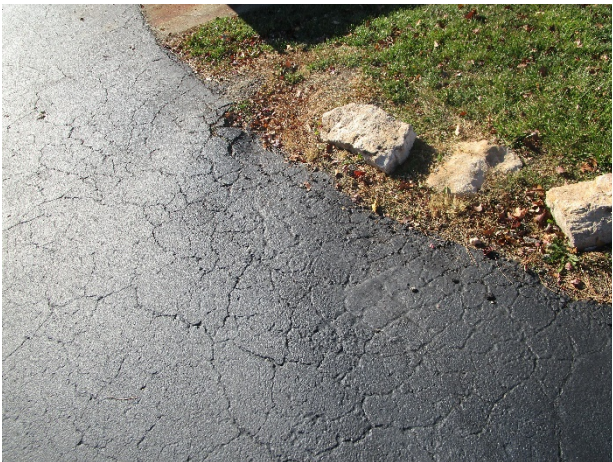
Pavement alligator cracks

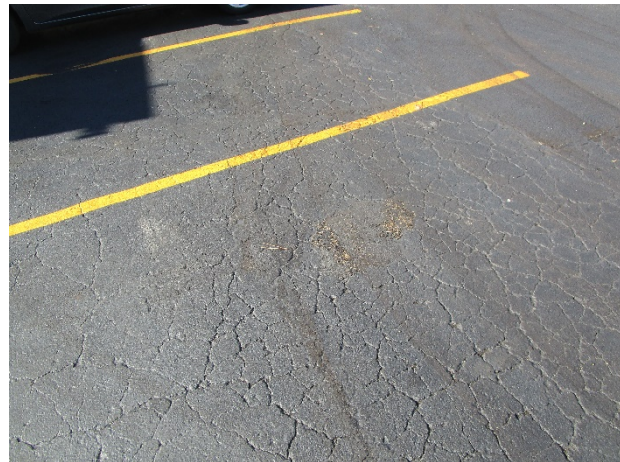
Pavement alligator cracks

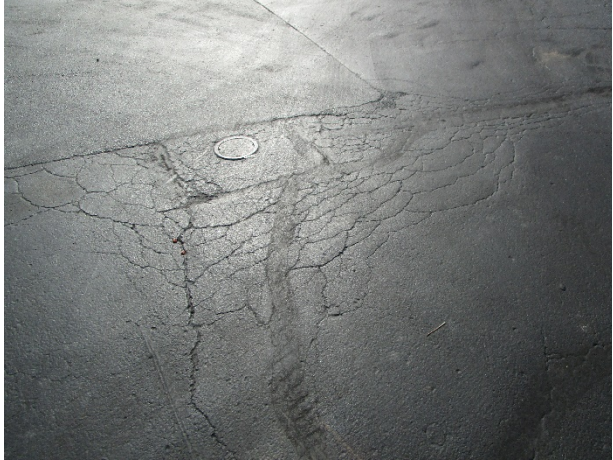
Pavement alligator cracks

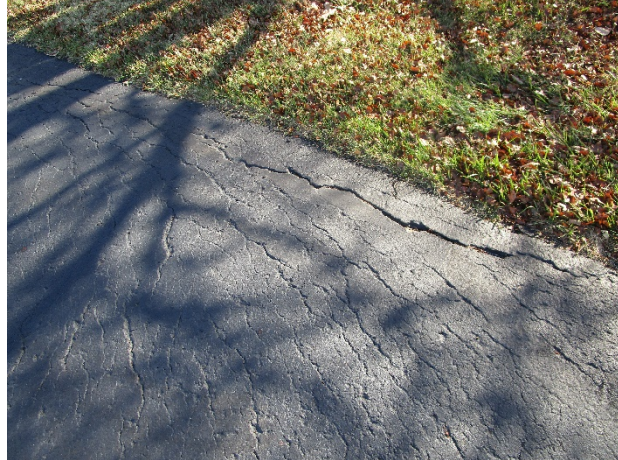
Pavement edge cracks

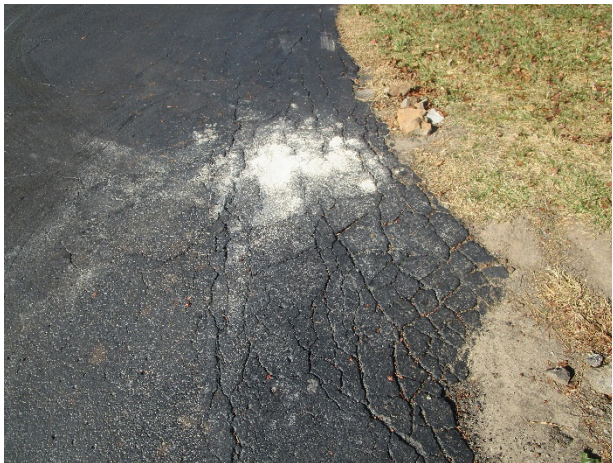
Pavement edge cracks

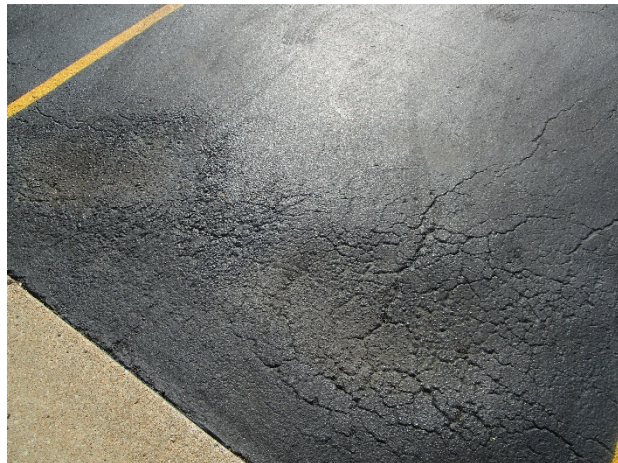
Pavement cracks and settlement

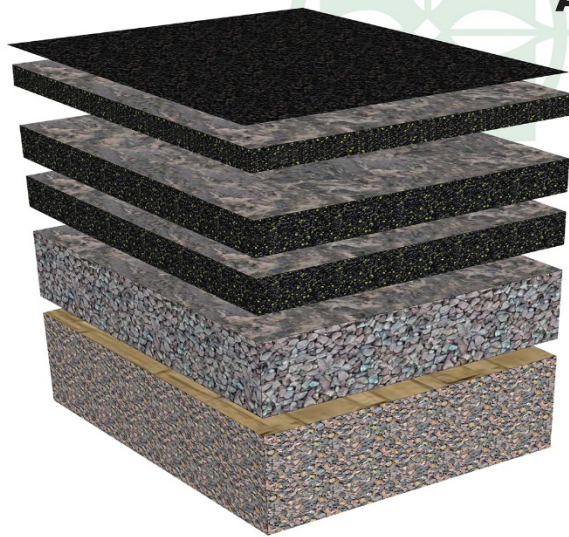
Component Detail Notes: The initial installation of asphalt uses at least two lifts, or two separate applications of asphalt, over the base course. The first lift is the binder course. The second lift is the wearing course. The wearing course comprises a finer aggregate for a smoother more watertight finish. The following diagram depicts the typical components although it may not reflect the actual configuration at Pheasant Run:

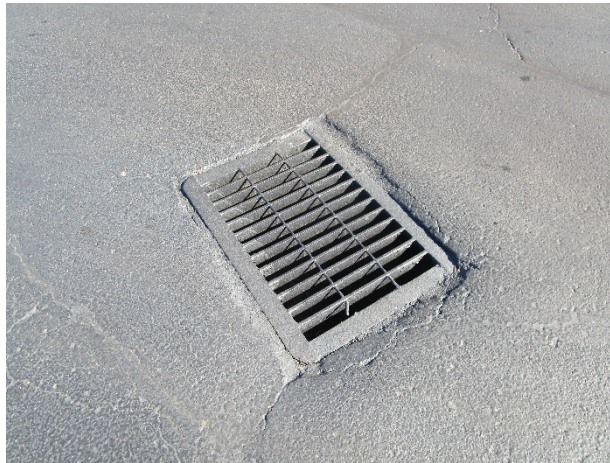
Catch basin overview

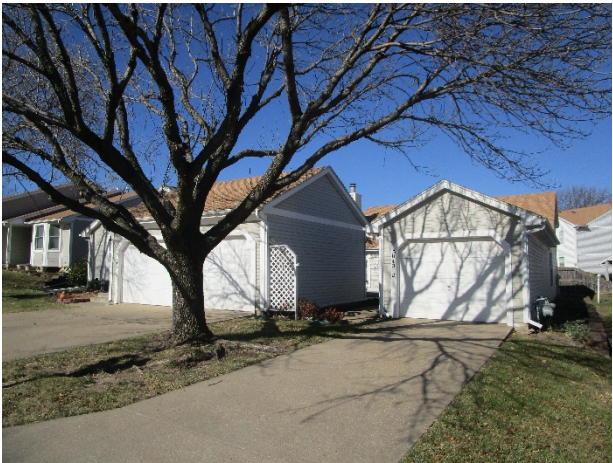
Concrete driveway overview

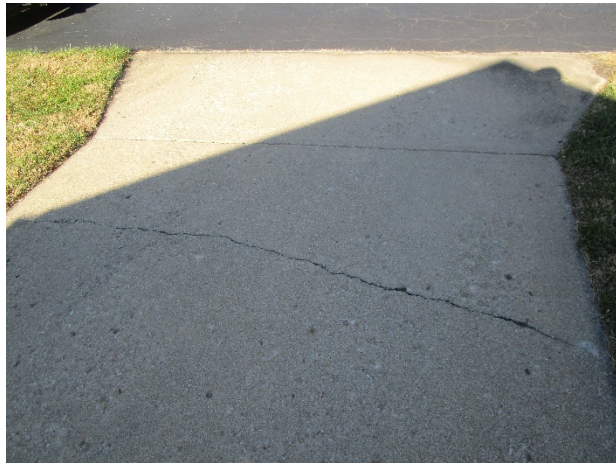
Driveway cracks at Building 5837

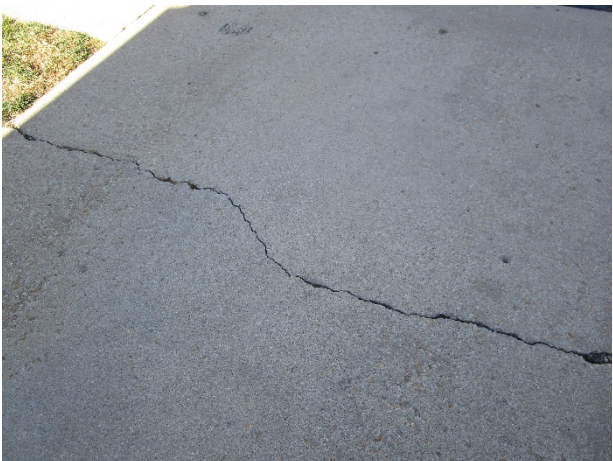
Driveway cracks at Building 5821

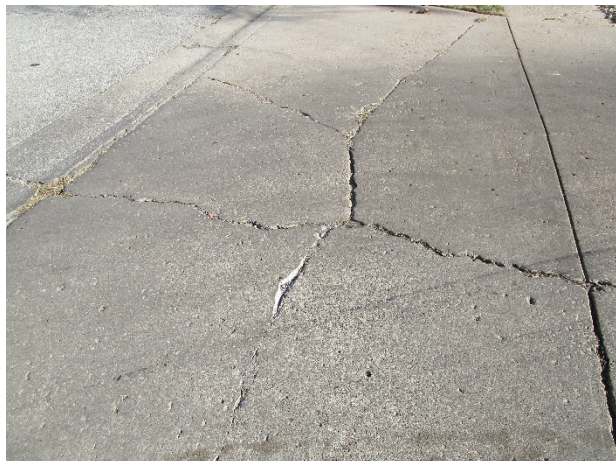
Concrete apron cracks

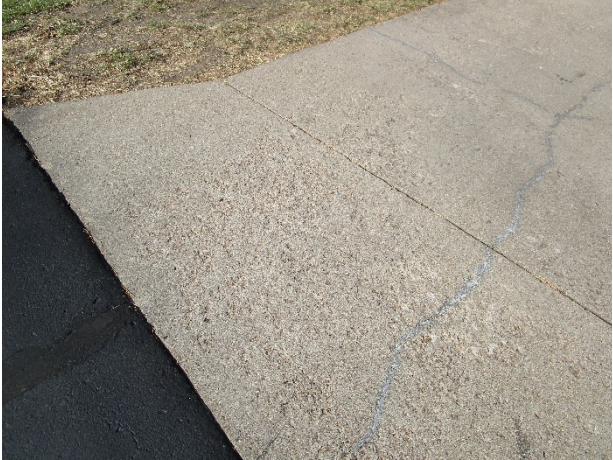
Driveway cracks and concrete spall at Building 5843

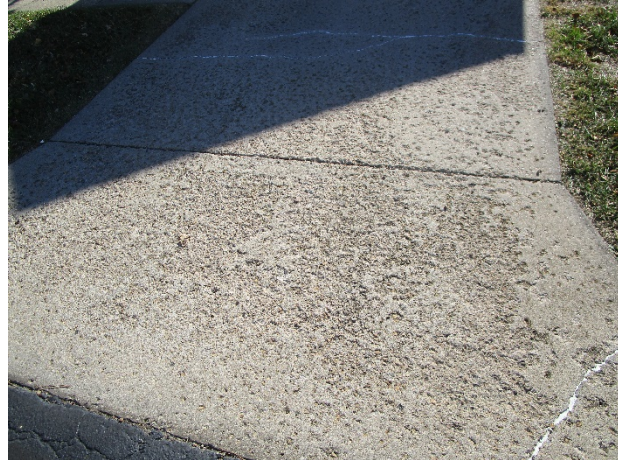
Concrete spall at Building 5831

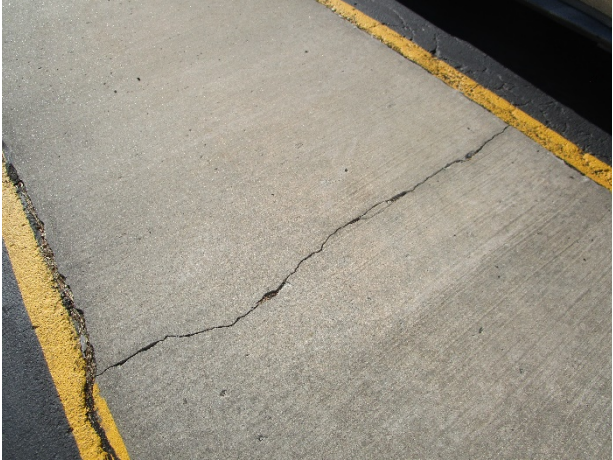
Common sidewalk cracks

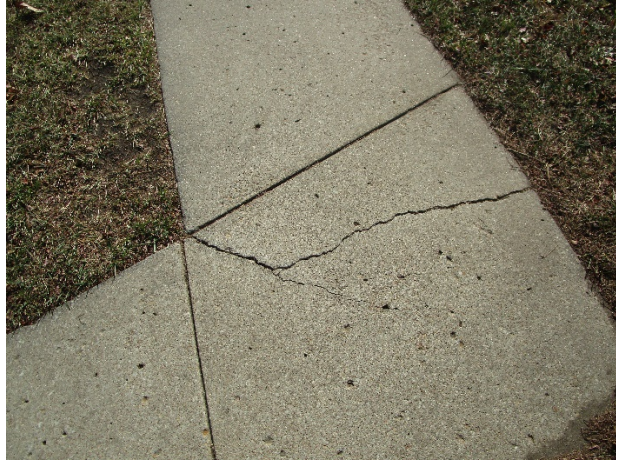
Common sidewalk cracks

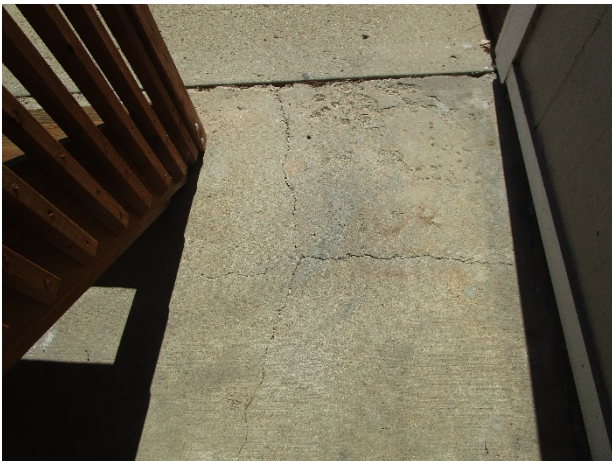
Sidewalk cracks at Building 5817

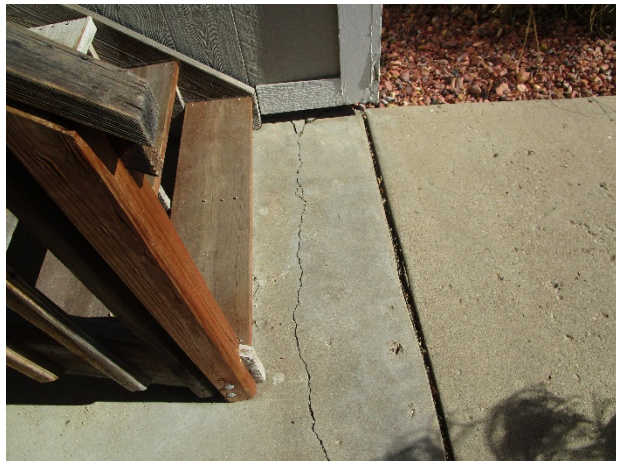
Sidewalk cracks at Building 5829

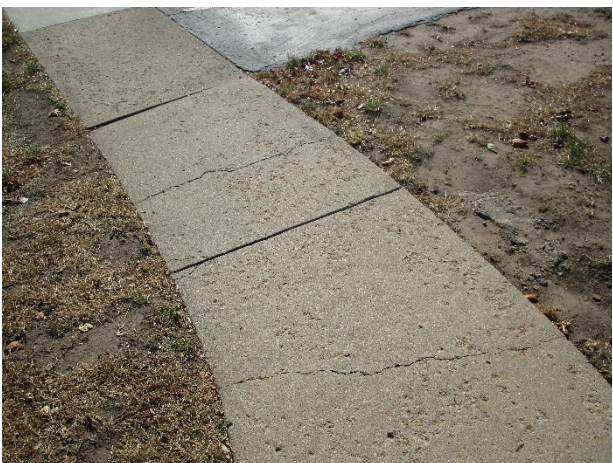
Common sidewalk cracks and concrete spall

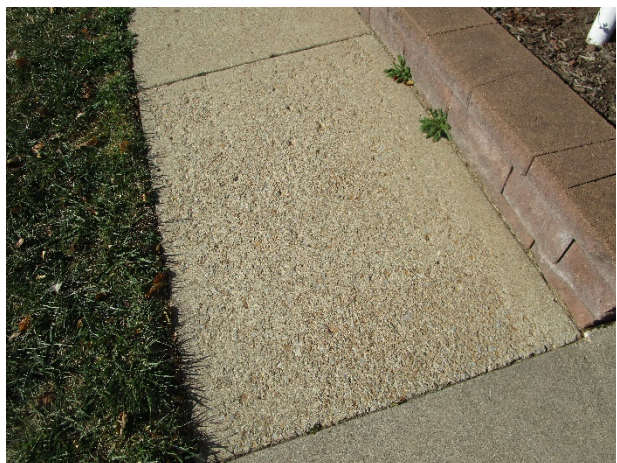
Common sidewalk concrete spall

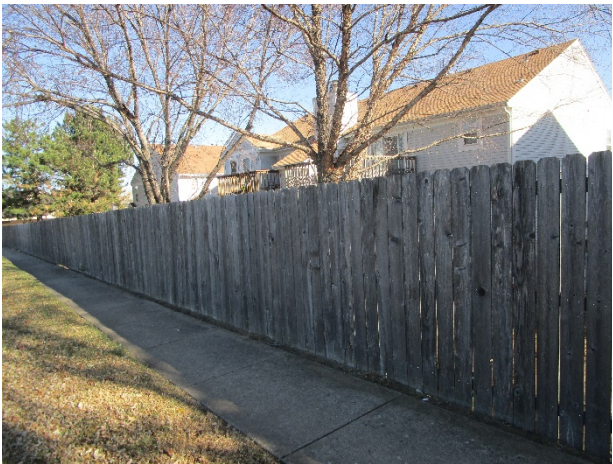
Front side of the wood perimeter fence

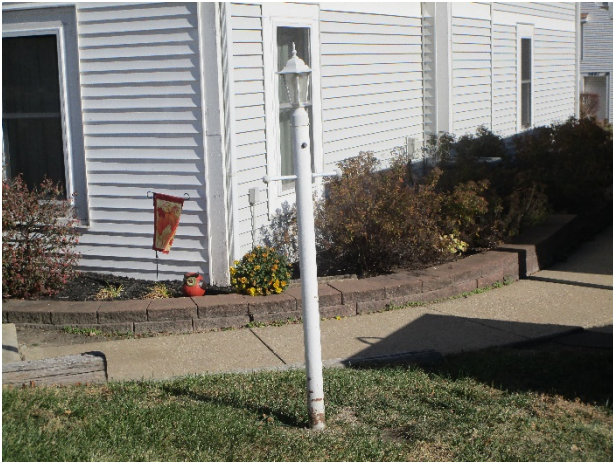
Light pole and fixture overview

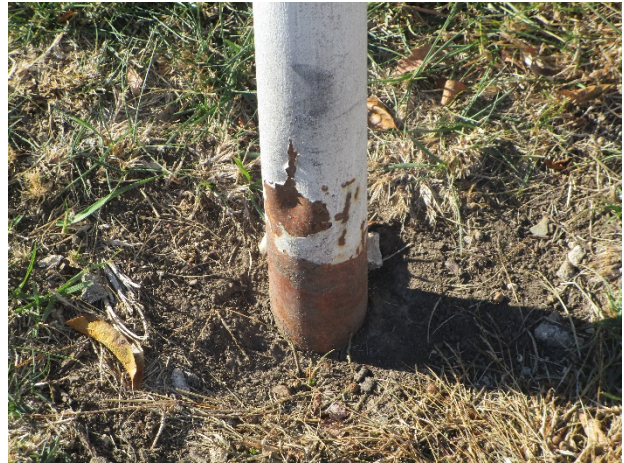
Rust at the base of the light pole

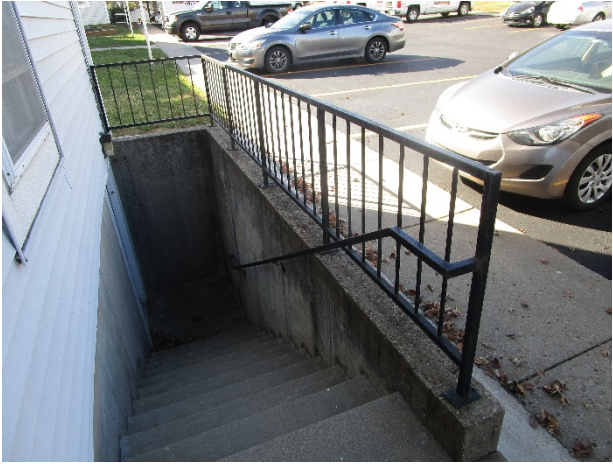
Condition: Good to fair overall with rust evident

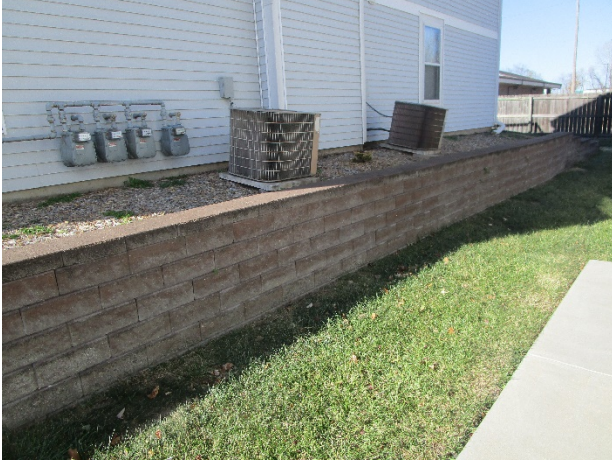
Masonry retaining wall

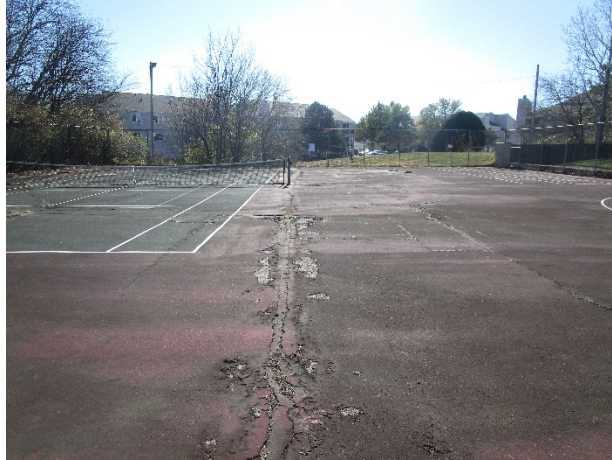
Sport courts overview; Note cracks and coating deterioration

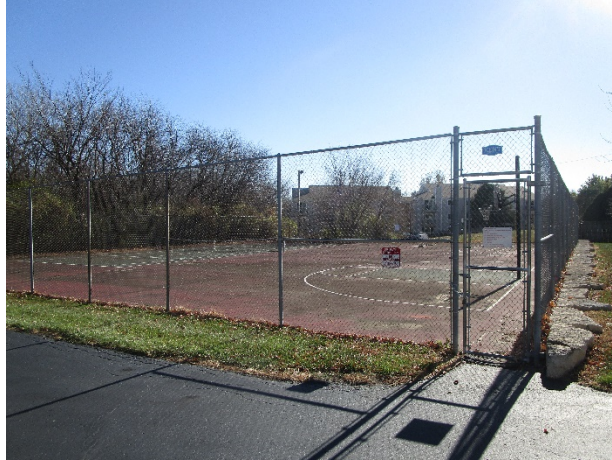
Condition: Good overall

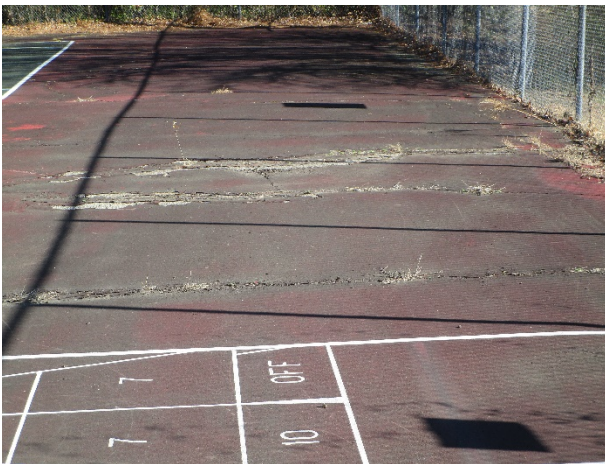
Condition: Fair to poor overall with cracks evident

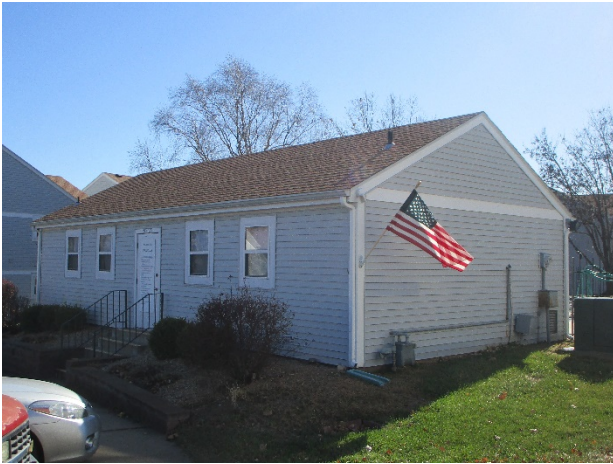
Pool house front and side elevation

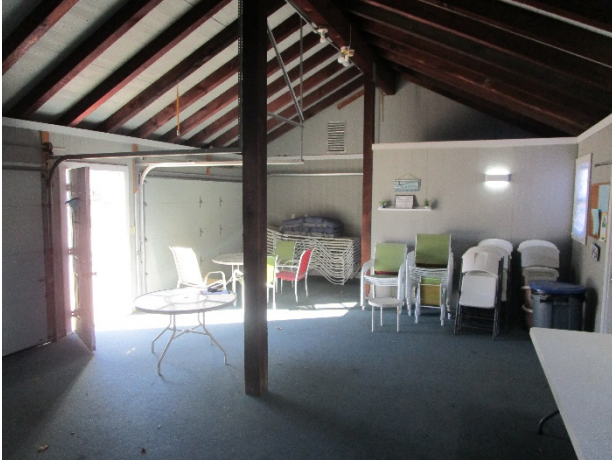
Condition: Good to fair overall

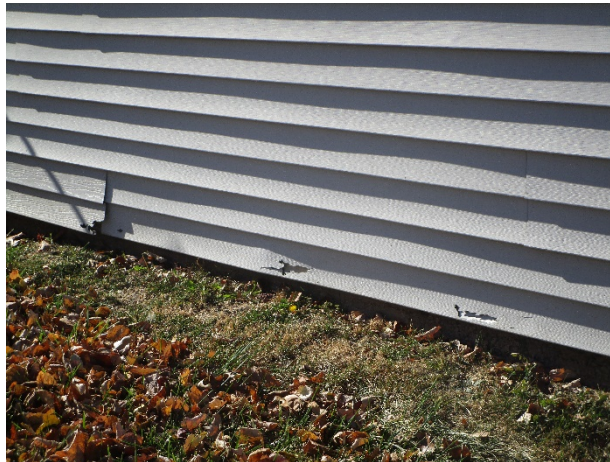
Condition: Good to fair overall with siding damage evident

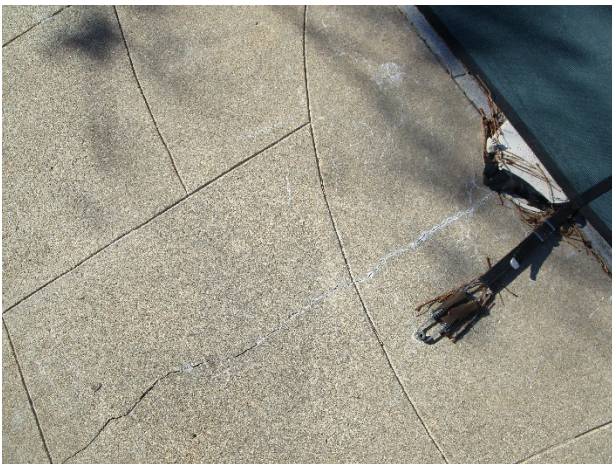
Condition: Good to fair condition with cracks evident

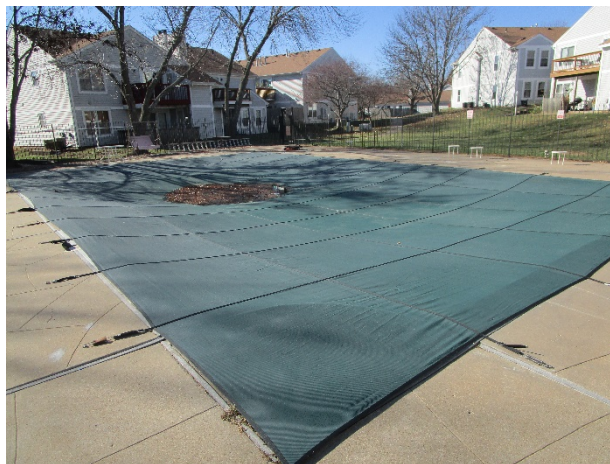
Condition: Good condition

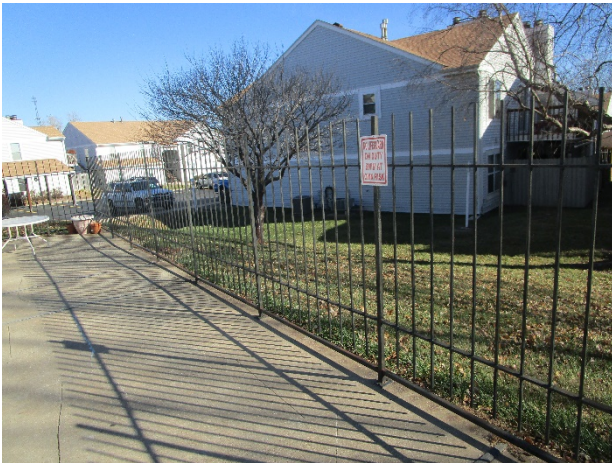
Metal pool fence overview

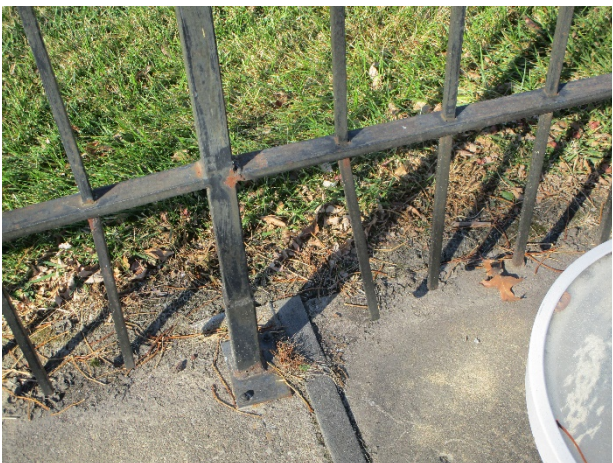
Rust and fence damage

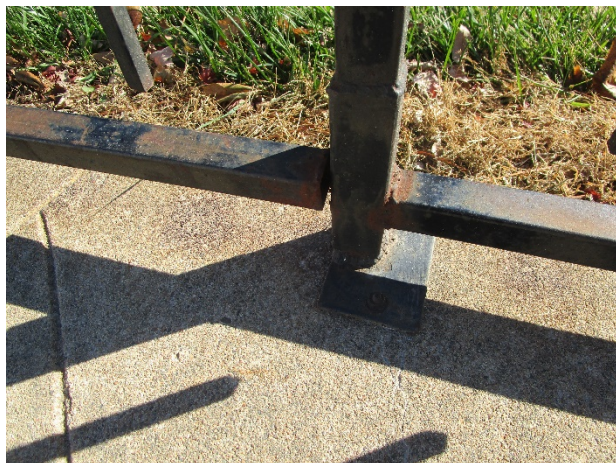
Rust and fence damage

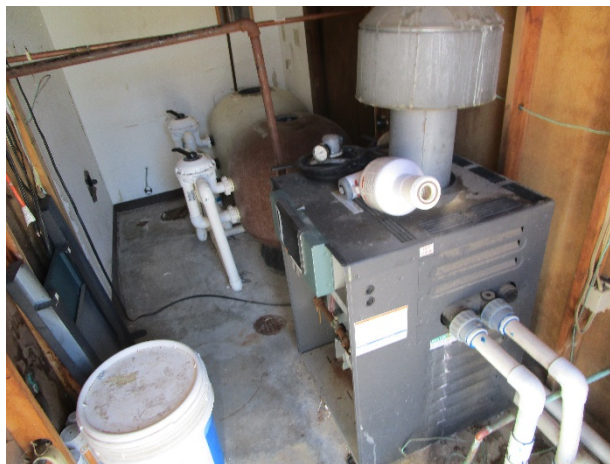
Mechanical equipment

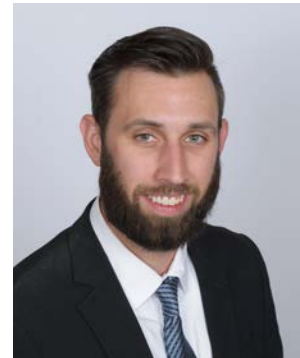
The following is a partial list of clients served by Nicholas Johanning demonstrating his breadth of experiential knowledge of community associations in construction and related buildings systems.
